Lawrence Livermore National Laboratory

UCRL-AR-126020-10

LLNL Ground Water Project 2010 Annual Report

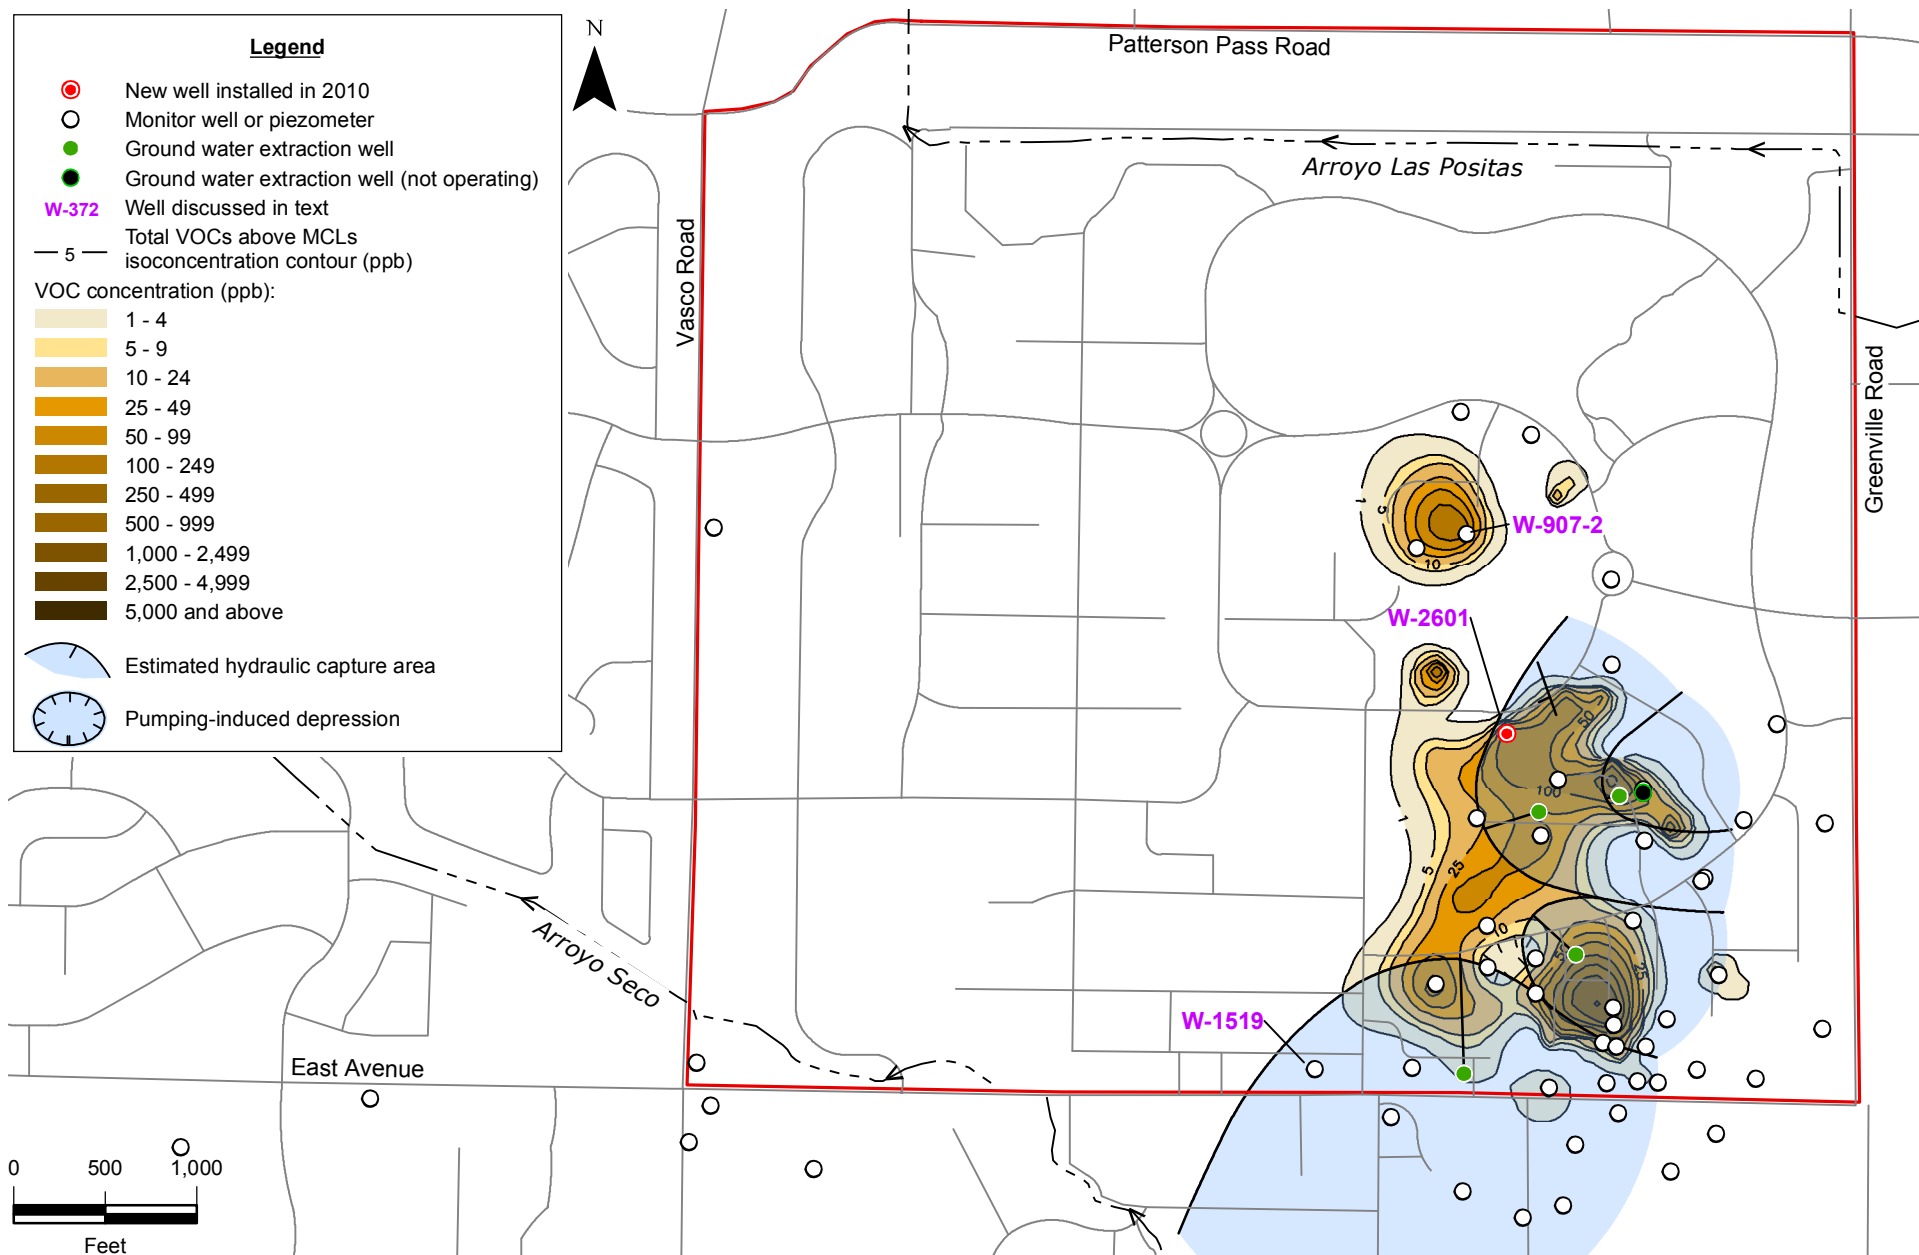
Figure 15. Isoconcentration contour map of total VOCs above MCLs from 60 wells completed within HSU 5, third quarter 2010 (or the next most recent data), and supplemented with soil chemistry data from 95 borehole locations.
